CAMELLIA HOUSE

description; the earliest known cast-iron pre-fabricated glasshouse in the world, dating from 1823, designed by Jeffry Wyatville.

status; listed building grade II*, within the Wollaton Park Conservation Area.

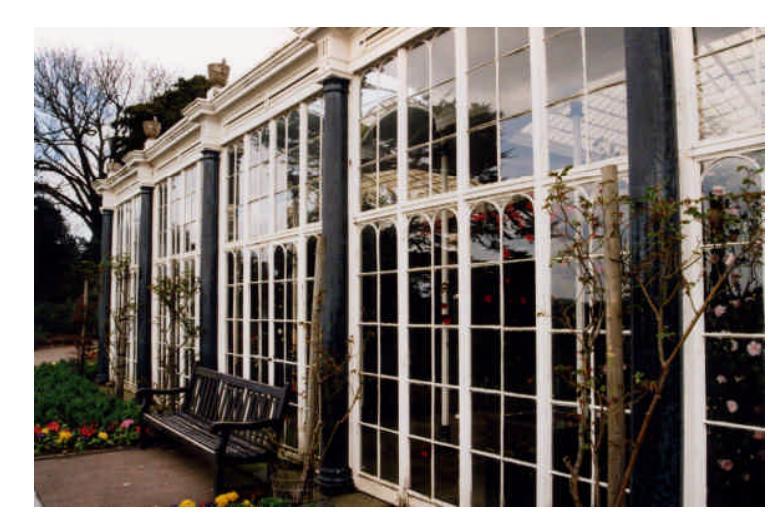
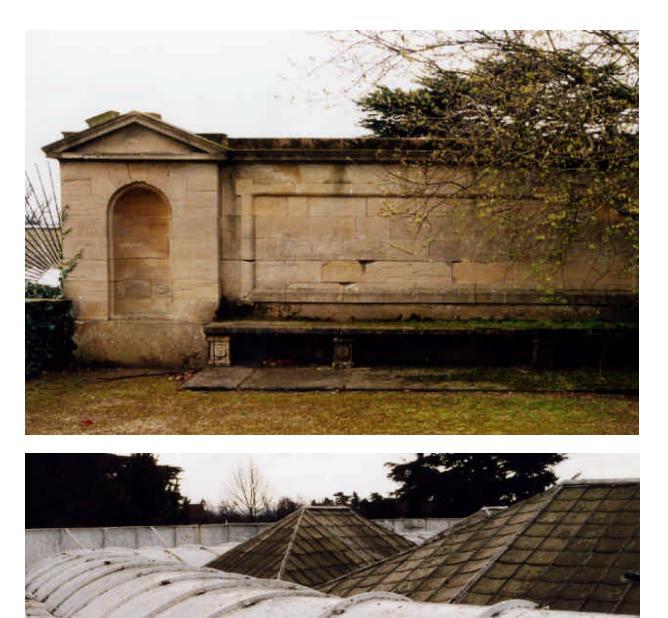
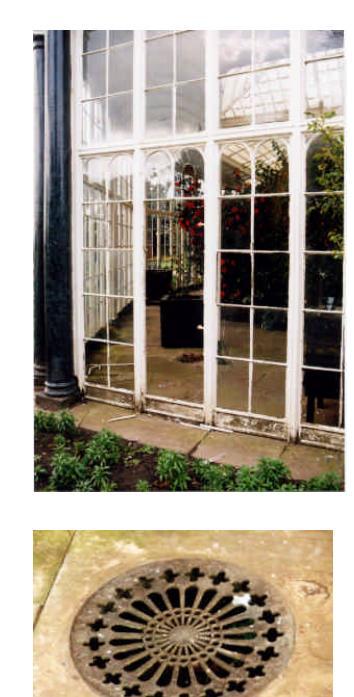
alterations; cast-iron urns have been replaced and several appear to be fibreglass copies. Much of the original glass in the roof has been replaced with "Lexan", a type of Perspex, which has discoloured white/opaque.

<u>condition</u>; due to wilful vandalism copper glazing bars have been ripped out and glass has been smashed. The cast-iron columns were repaired in the 1980's but these have further rusted and many need significant repair or replacement. There are integral design faults with the structure that can only be overcome by an effective programme of maintenance and by judicious techniques of preparation and repair of cast-iron. To the terrace, some of the cappings to the niches have been displaced. <u>further investigation</u>; key decisions on the maintenance of the structure, as well as immediate and long-term repair need to be informed by expert fabric conservation consultant's opinion.

<u>vulnerability</u>; maintenance is minimal and the structure requires regular continual maintenance and more effective monitoring to deal with any issues of vandalism immediately so that the impression is not one of abandonment.
